Guided Auger Boring Project Under UPRR Tracks in Sacramento CA

By: Justin Peterson, Carollo Engineers, Inc.
Mary Neher, Bennett Trenchless Engineers

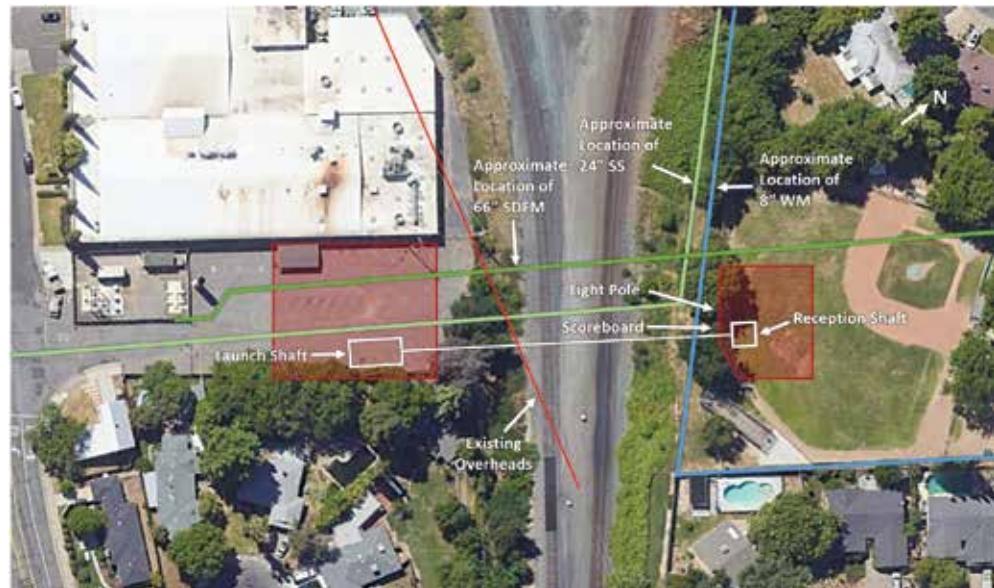
Figure 1. Aerial view of guided boring crossing of the two sets UPRR tracks showing key project constraints. Work areas are shown shaded in red.

utilities between the UPRR right-of-way and outfield fence, the smaller receiving shaft was located in the ballpark's centerfield. Work areas were identified on both sides of the crossing to limit impacts to operations of the industrial laundry and to minimize necessary restoration in the baseball field. The launching and receiving shafts and their work areas for the 250-foot trenchless crossing are shown in Figure 1 with key project constraints.

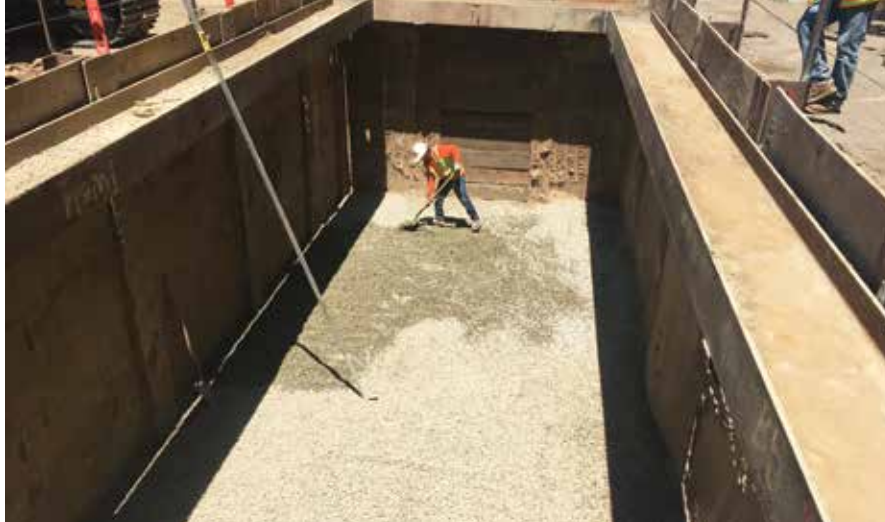
Figure 2. Launch shaft constructed using soldier piles with steel plate lagging due to low groundwater and stable ground conditions.

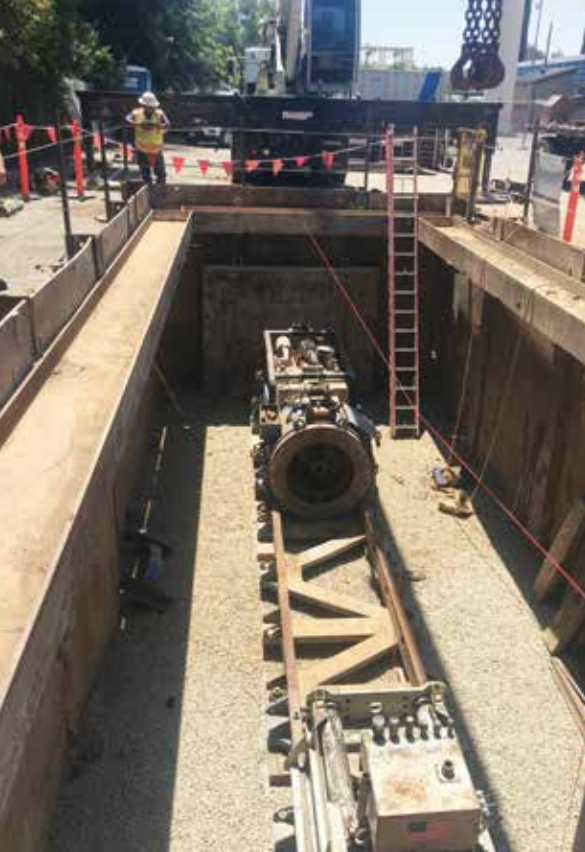
Figure 3. Auger boring rig set in the launch shaft with pilot tube guided boring equipment in foreground. Installation of 250 feet of guided pilot tubes took two hours.

day. A UPRR representative was on site throughout guided boring operations to ensure that the approved work plan was followed. Pacific Boring began installation of the pilot tubes at 10:30 in the morning and by 12:30 had successfully installed the tubes to the back of the shoring in the reception shaft. The pilot tubes were pushed into the reception shaft and survey confirmed that they had been precisely installed on design line and grade. With plenty of work hours remaining in the day,

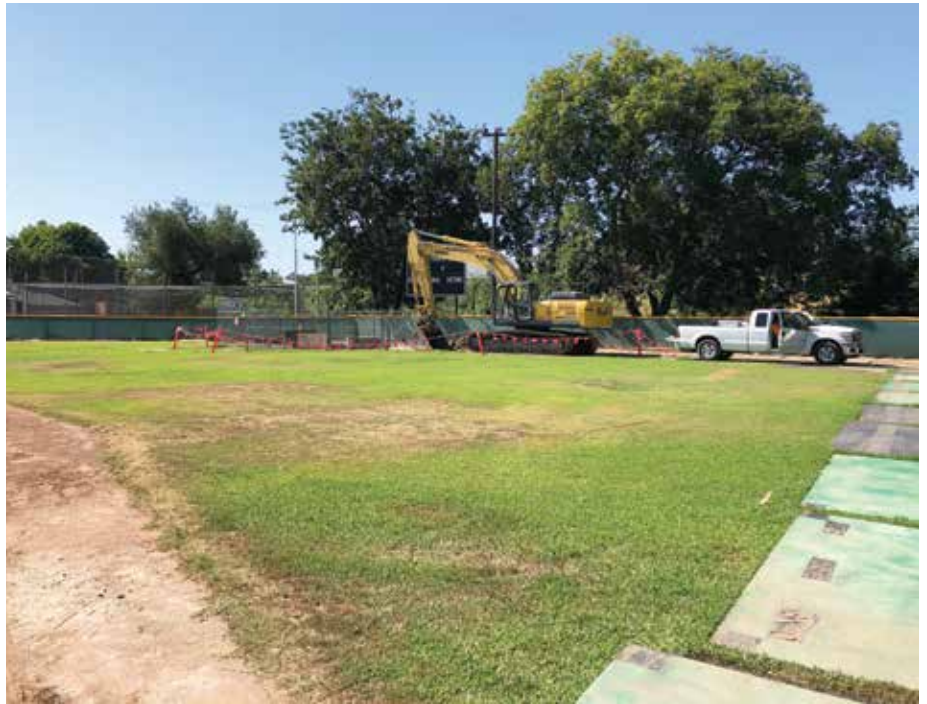
Figure 4. Reception shaft located in community baseball park's centerfield. Careful coordination with local baseball league was required and construction schedule was restricted to minimize construction impacts on community.

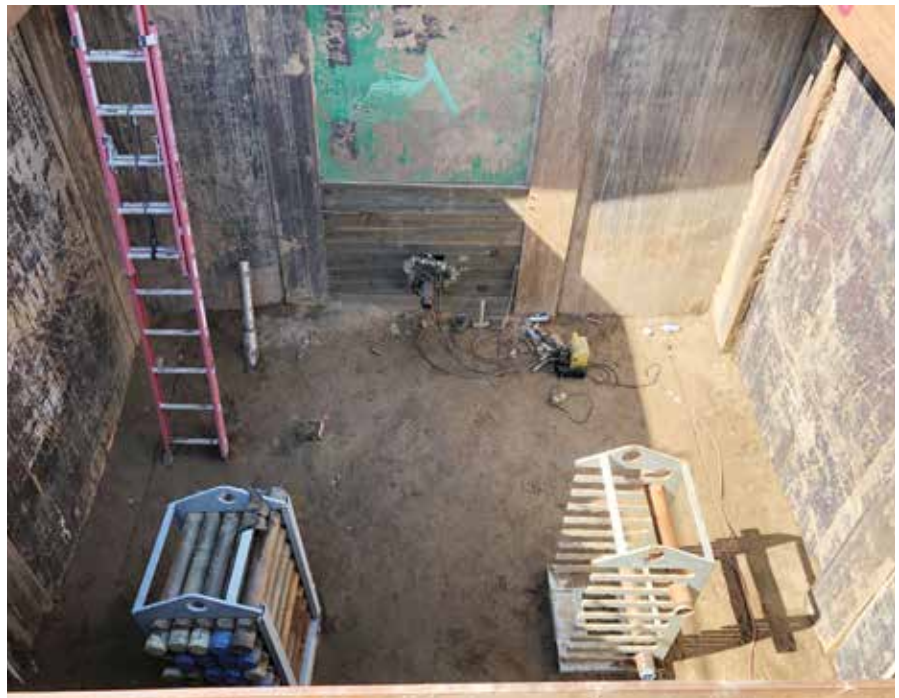
Figure 5. Pilot tubes entering reception shaft and being removed as 20-inch casing is advanced. Pilot tubes entered reception shaft precisely on line and grade.

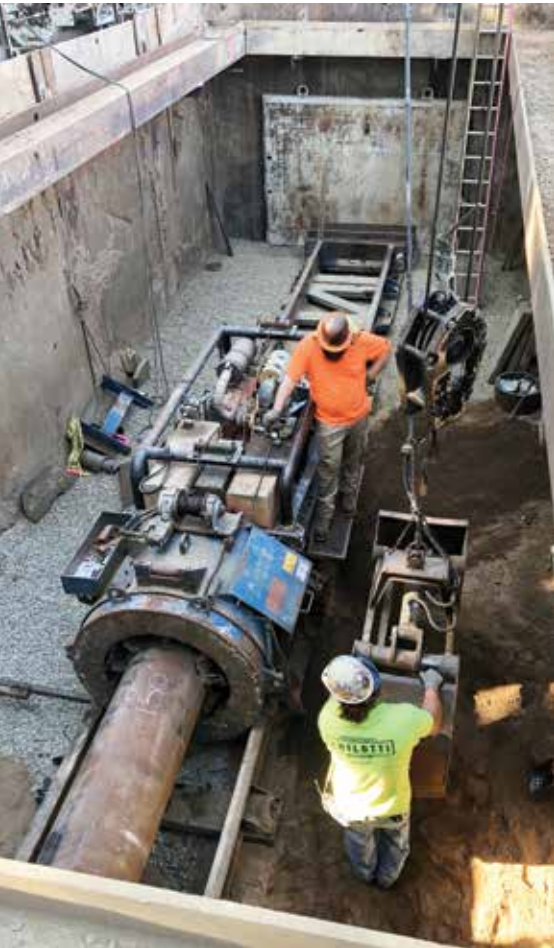
Figure 6. Auger boring installation of 20-inch casing beneath two sets of UPRR tracks.

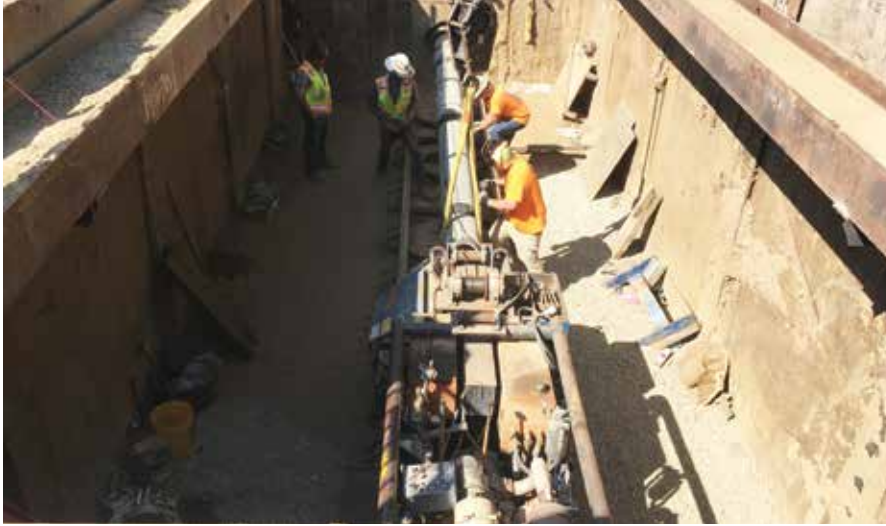
Figure 7. Installation of 12-inch cement-mortar lined and coated steel carrier pipe inside the 20-inch casing installed with guided boring took three days.

Pacific Boring then proceeded to remove the pilot tube equipment from the pit and completed installation of the first section of 20-inch casing. Installation of the remaining 240 feet of 20-inch casing took place over the following two days. Installation of the 12-inch cement-mortar lined and coated product pipe inside the steel casing was completed in three days, completing the trenchless components of the project.
